Annex III – Short public report. STSM

Title of the STSM: Tailored properties of Novel Acrylic/Glass Composites via Liquid Resin Healing at Elevated Loading Rates – Manufacturing and Testing

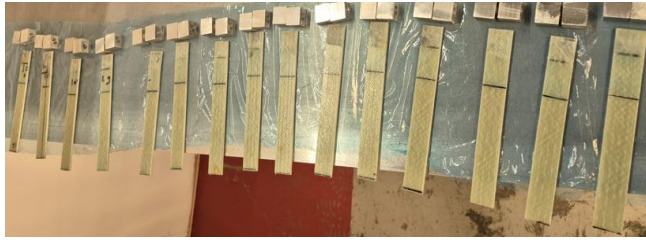
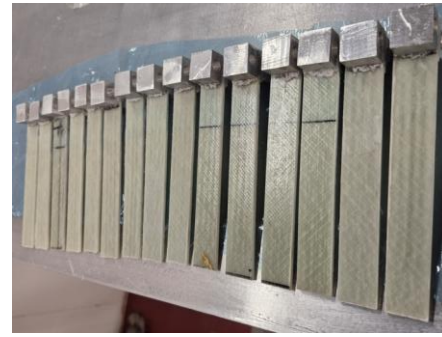
Figure 1: The composite coupons (virgin) for the DCB tests (3, 6 and 9 mm/min).

This STSM investigated Mode I delamination in composite structures such as wind turbine blades (WTBs), focusing on high-velocity impacts and leading-edge erosion, which can induce tensile stresses and interface weakening. Triaxial glass fabric (U-E-1182 g/m²-1270 mm, Cristex), with four layers (+45/0/-45), was used as reinforcement for the recyclable Elium resin, which had an extended gel time, making it suitable for producing and repairing large components, such as WTBs and boats. Figure 1 presents the composite coupons (virgin) for the DCB tests (3, 6 and 9 mm/min). Figure 2 shows the repaired DCB coupons. Figure 3 shows the testing of virgin DCB samples. Figure 4 presents the testing of healed (tailored) DCB samples. Experimental results showed that all repaired samples outperformed the virgin ones in delamination load, not only at the standard crack opening rate (3 mm/min) but also at a higher crack delamination rate (9 mm/min). This behaviour can result in fracture toughness values related to crack initiation and propagation in the repaired samples that are higher than those of the virgin one. Fractographic evidence supported these findings, confirming the effectiveness of liquid thermoplastic resin injection as a healing method that enhances interlaminar ductility at repaired bond lines. The results of this study contribute to sustainability and reduced CO₂ emissions by increasing the life cycle of the composites. The work supports the deliverables of WG3 and WG6, advances the use of sustainable materials, and strengthens collaboration between European partners.

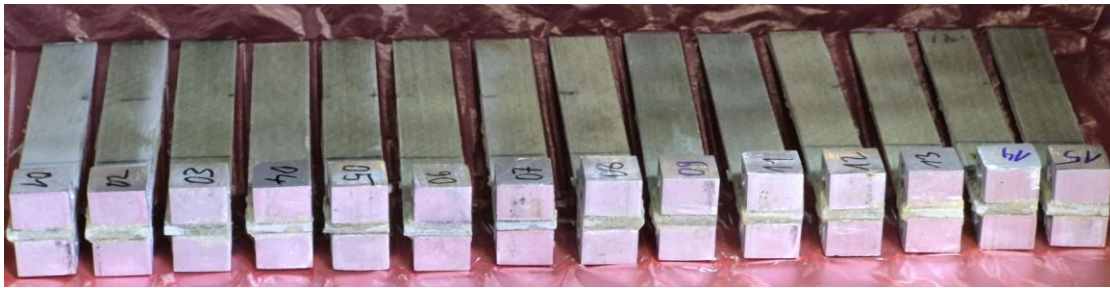
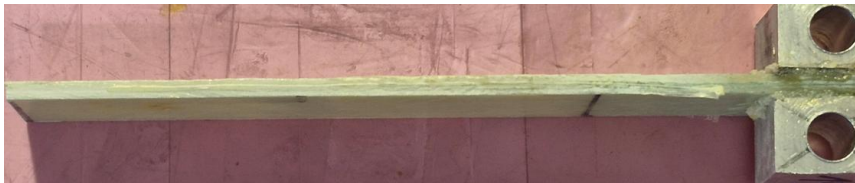
Figure 2. The repaired DCB coupons.

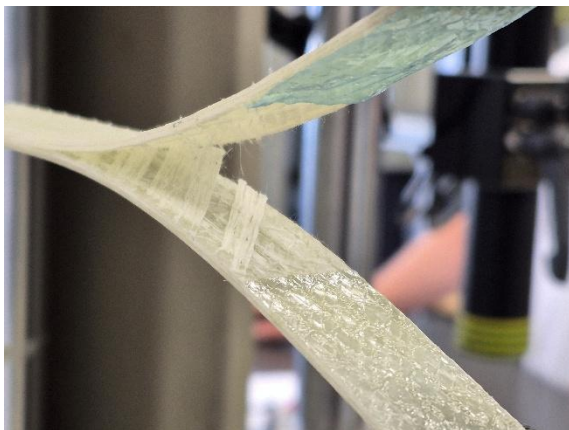
Figure 3: Testing of virgin DCB coupon.

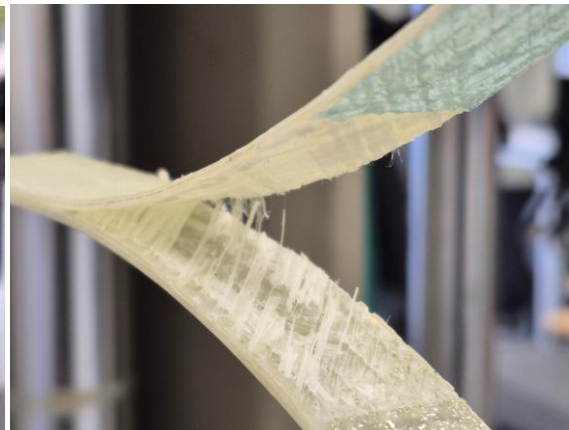
Figure 4: Testing of healed (tailored) DCB coupon.
